Mammoth Lakes Fire Protection District

Title: Wood Burning Insert Issue Paper

Date: April 2, 2012

Author: Thom Heller, Fire Marshal

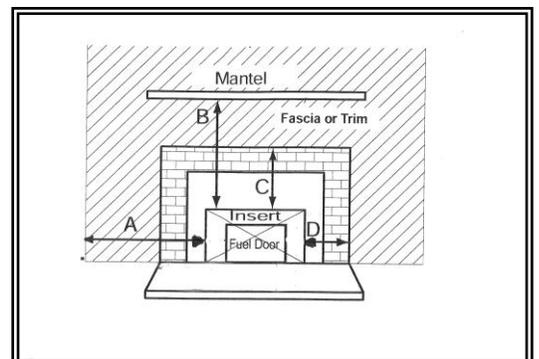
Figure 4

Figure 4- Insert instructions provide distances to combustibles as determined by insert manufacturers. Critical distances are “B” distance to mantel or similar projects of the visible wall. “C” distance to combustibles inside the wall above the insert (behind fascia material). “D” distance to combustibles inside the wall alongside the insert (lateral to the insert).

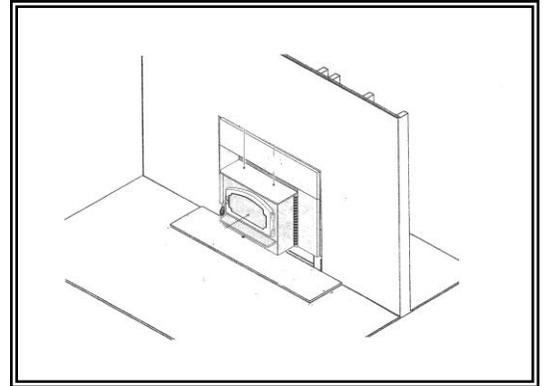
Figure 5 -With fascia in place, it is very difficult to determine the location of combustibles behind the fascia material. The first step in determining if a problem exists will be to determine if there is still a Fireplace box in place. This would involve taking the metal shrouding off from around the insert. If a Fireplace box is found then further investigation is needed. In some situations access to the construction material behind the fascia may be obtained through the exterior of the chimney chase. In most cases, getting to the appropriate location will not be possible and portions of the fascia will need to be removed to determine construction material behind.

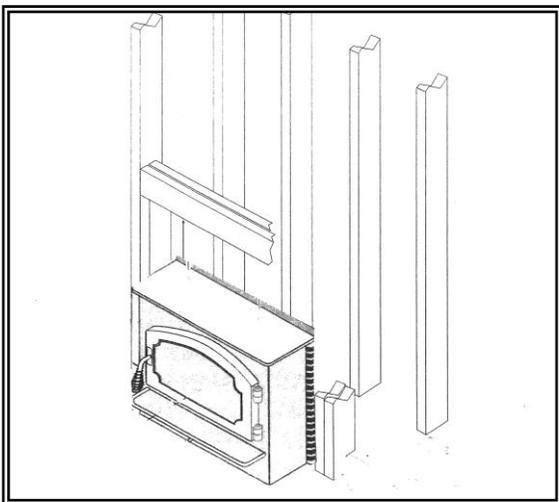
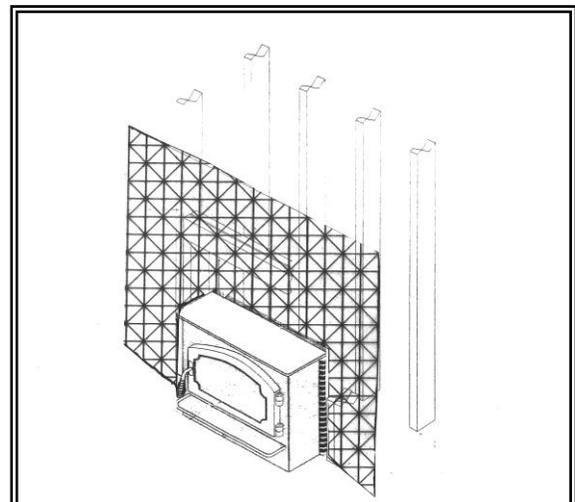
Figure 6/Figure 7- The area of concern is the immediate area around the insert. In these pictures the Fireplace box has been removed, but the area of concern is the distances to combustibles that is required for a proper installation of the insert. Distances vary with insert models, but all insert manufactures have a required distance that must be achieved to protect the combustibles from a structure fire. The shaded area in Figure 7 is the area of concern. Any combustible materials (wood, plywood, sheetrock, etc) could result in an unwanted structure fire.

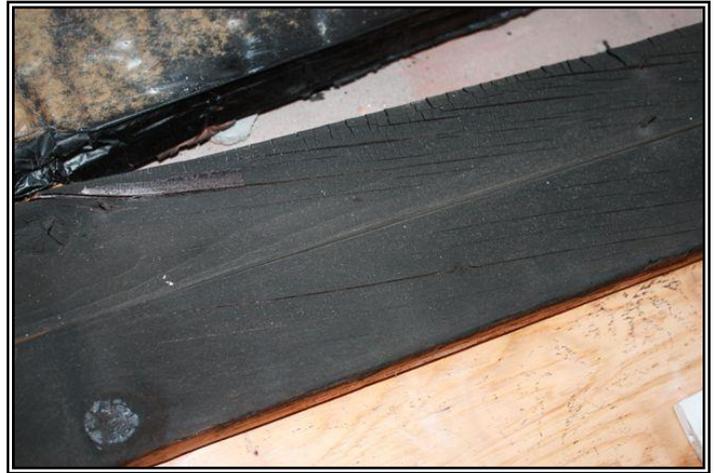
Photo 1 is pyrolysis (the slow baking of wood) that occurred to a header board in a wall of a condo unit that did not catch fire. Pyrolysis caused a charring (blackening) of the wooden material and a lowering of the ignition temperature which makes it more susceptible to ignition. This is an example of well-developed pyrolysis found in a frequently occupied condo unit.

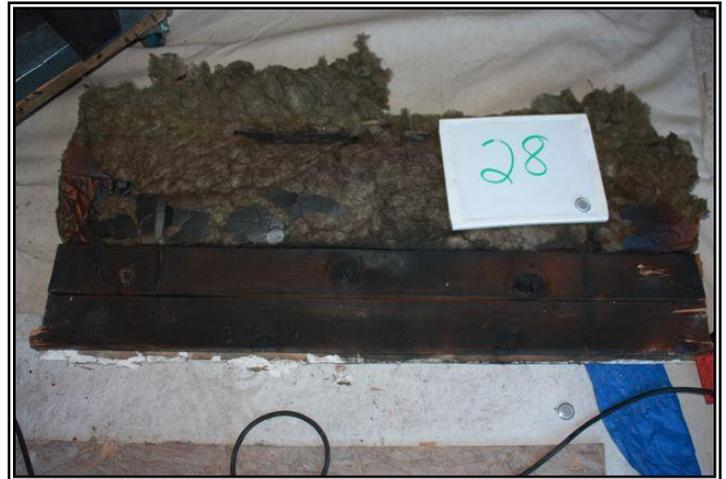
Photo 2 is pyrolysis of a 2x4 header that was removed from a condo unit that did not show signs of fire activity. Note the paper on the insulation has completely burned away, except for a few small pieces.

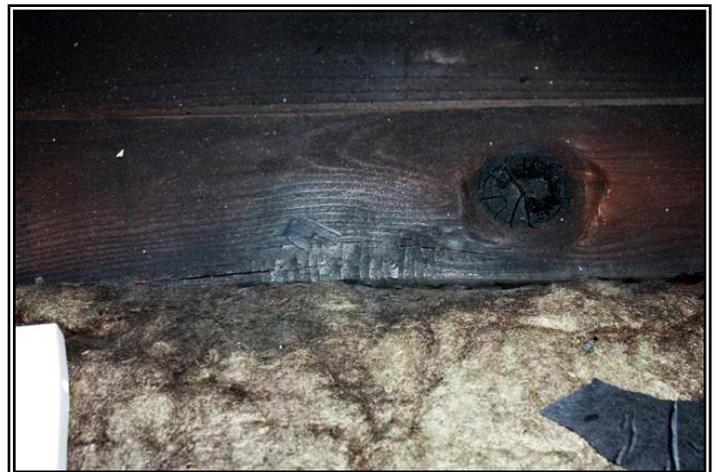
Photo 3 is advanced pyrolysis found in another condo unit. Note the alligator cracking (advanced charring), This also shows the burning away of the paper from the back of the insulation

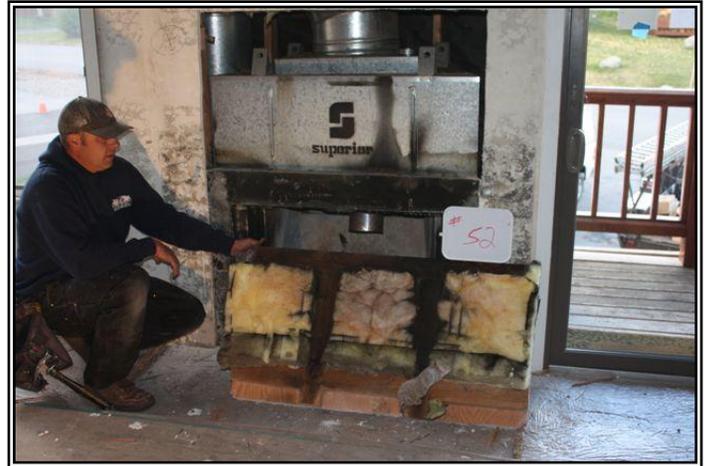
Photo 4 The picture demonstrates the seriousness of the problem. The wall section directly above the center of the insert has been removed (it is upside down). You can see the advanced charring and soot marks on the metal behind the wall section. This section is close to igniting and causing a fire.

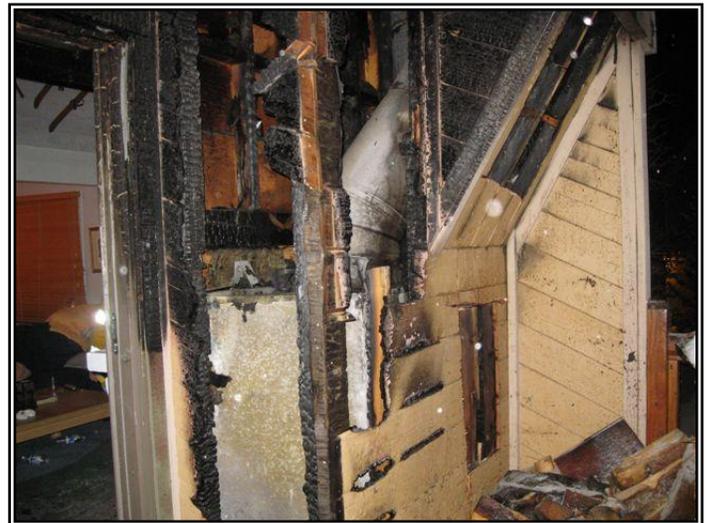
Photo 5 is an actual fire caused by pyrolysis around a wood fireplace insert. Fire occurred in March of 2010, fortunately no one was hurt.

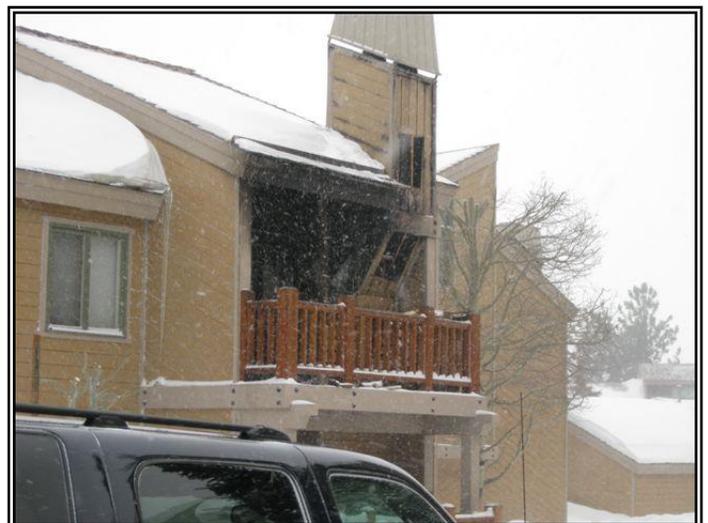
Photo 6 Same fire.

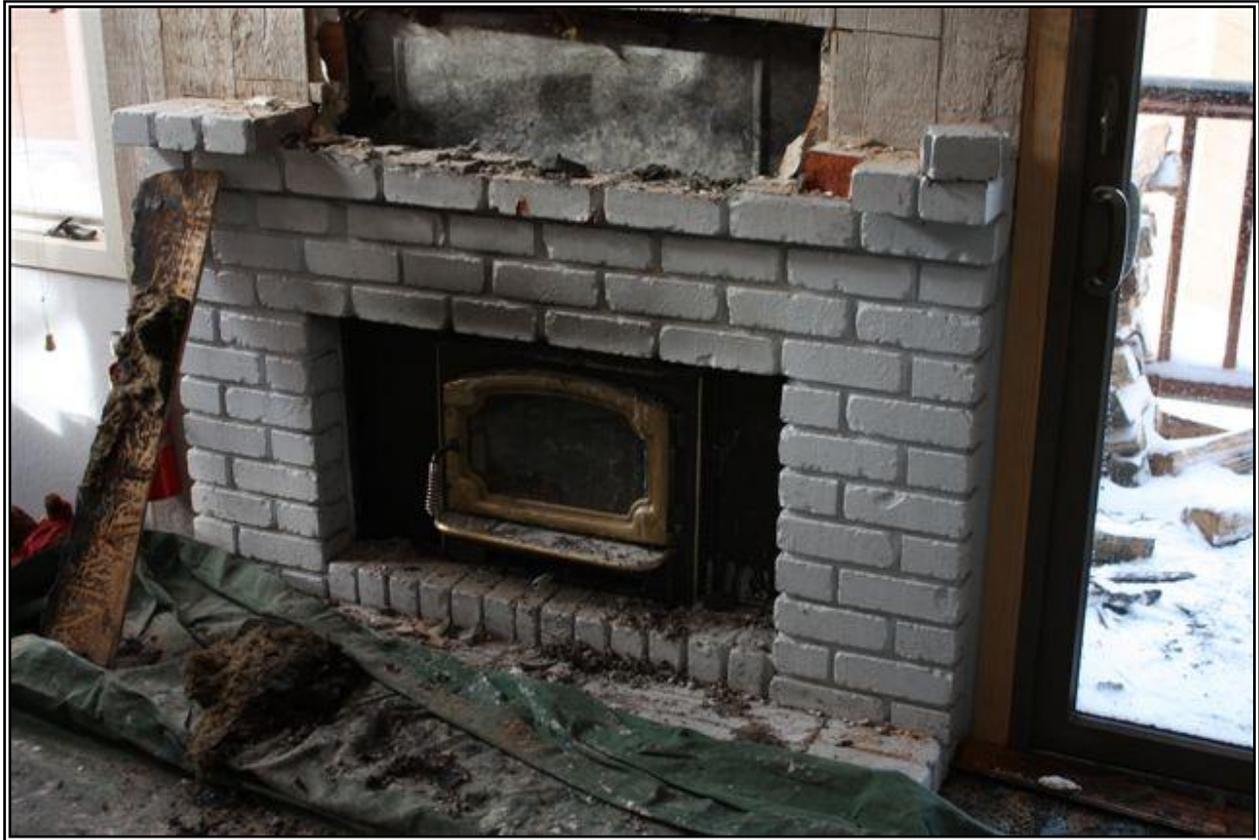
Photo 7 shows the whole problem. This is where the fire started (in the last two pictures). You can see the original “zero clearance” fireplace with the wood burning insert. The slow pyrolysis over time finally ignited in the area where the bricks are missing. The fire proceeded further into and up the chase. In many cases in order to find the damage, you need to remove the façade, in this case the bricks, and cut into the wood framing behind the façade.
